## Geomorphic-based mine rehabilitation coupled with AMD chemical stabilisation in sulphide-rich ore deposits and soils: insights from a pioneering intervention at the Lousal mine, Iberian pyrite Belt

The Lousal mine rehabilitation project proactively planned strategic milestones around key local geomorphic landforms and geochemical characteristics. GeoFluv™ method was used to design a rehabilitation topography mimicking natural landforms, on which a built-up soil cover with chemical buffering capabilities and open limestone channels were implemented across the intervention areas. Once these landform restoration works were completed, positive effects are observed in March 2022, with the native vegetation cover (the third main component of the restoration plan) established in most of the recovered area and a visible water quality improvement to the AMD treatment system water. Potentially Toxic Elements (PTEs) concentrations have reduced significantly after the reclamation actions, especially Fe (404 to 34 mg L<sup>-1</sup>), Zn (65.7 to 15.8 mg L<sup>-1</sup>) and Cd (122 to 0.8 µg L<sup>-1</sup>) concentrations. Minor problems detected have been processes of rill erosion associate

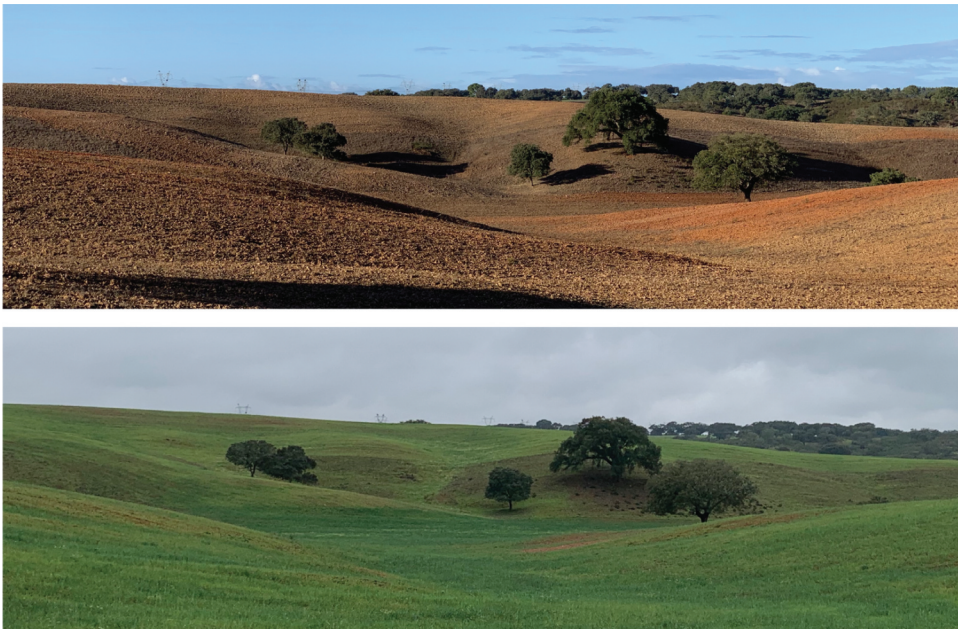
**Figure 4.** The GeoFluv rehabilitation method aims to design and construct landforms similar to those found in mature landscapes, including scalloped morphologies and convex-concave hillslopes. Upper image: Agricultural landscape in the Lousal – Faleiros area (Grândola, Portugal) in October 2021. Lower image: the same landscape in February 2022.

Natural Regrade software facilitates making GeoFluv designs in a Computer Aided Design (CAD) format [14,19,20,35,37]. This method enables mature and natural landform creation, with the formation of steady-state landscapes which seek to balance erosive and resistance forces. Mining

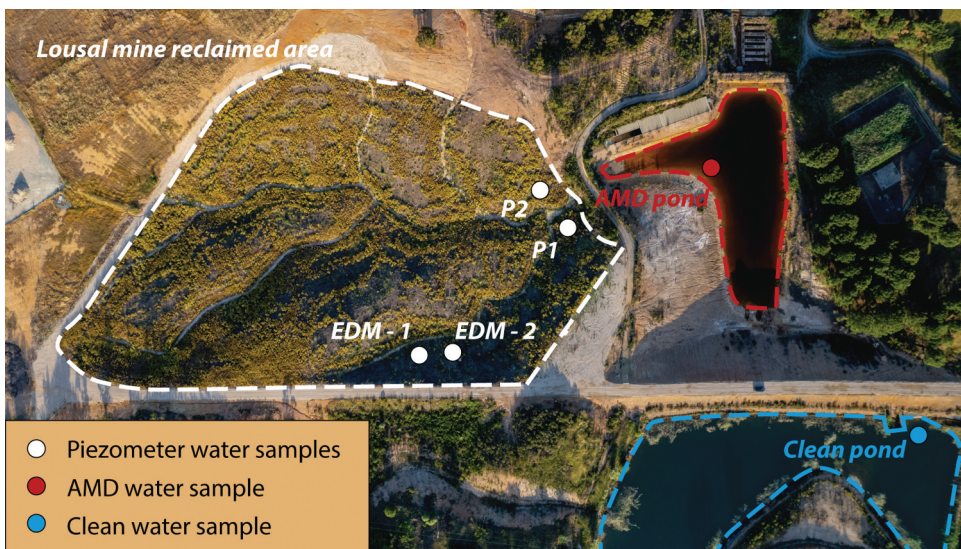
Figure 5. Location of the water samples collected as part of the monitoring actions in Lousal.

To monitor the evolution of water quality and riparian ecosystems near the reclaimed area, two new piezometers (P1 and P2) were installed in lower sections of the intervention area, with intakes designed from previous geophysical studies. Piezometer P1 was drilled to nine metres (60 mm diameter), with its perforated screen located between metres seven and eight. Piezometer P2 was shallower (six metres), had the same diameter and its perforated screen was located between metres four and five.

In May 2022, the first water quality monitoring sampling was carried out, collecting a composite groundwater sample from each of the new monitoring piezometers (P1 and P2), and two pre-existing piezometers (EDM – 1 and EDM – 2) (Figure 5). To ensure the collection of representative samples, all piezometers were purged 24 hours in advance. Groundwater was collected using a PVC Bailer, which was thoroughly cleaned with distilled water between samples. In addition, two surface water samples were also collected from the AMD pond located at the outlet of the reclaimed area (AMD pond) and from a clean water pond located upstream (Clean pond) (Figure 5). All water samples were kept refrigerated until they were sent for analysis.

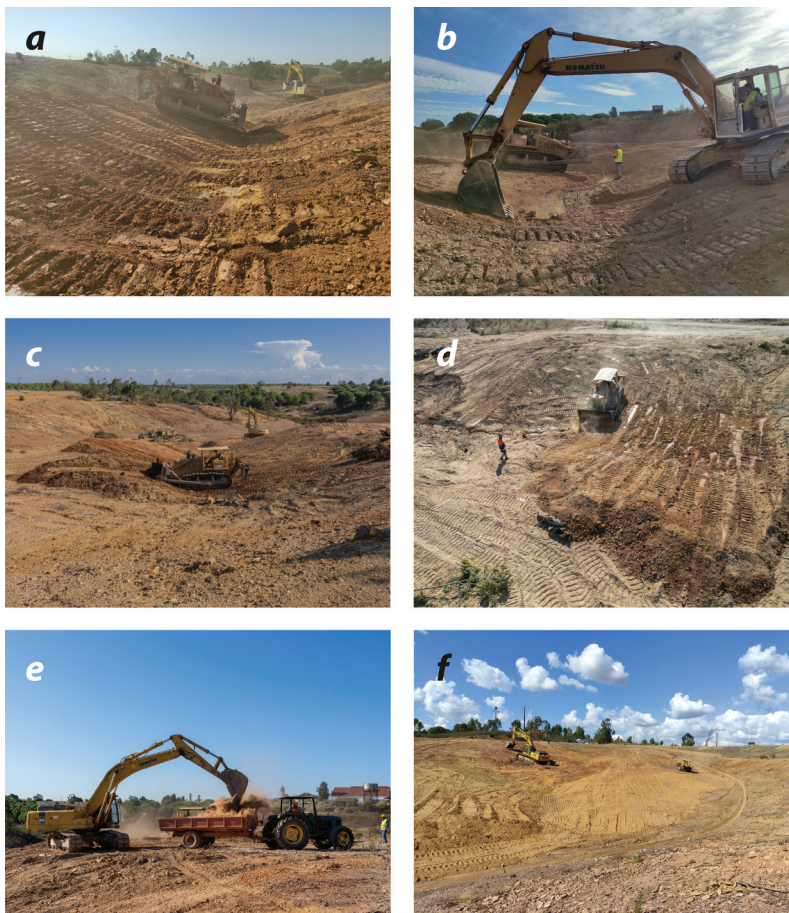
**Figure 7.** Geomorphic regrading actions: a), b), c) and d) Bulldozer and excavator constructing new rehabilitation topography; e) back-up tractors used for earth moving; f) view of the intervention area during late-stage of topographic regrading.

The Lousal mine geomorphic-based rehabilitation was undertaken between September and October 2021 (Figure 7). Prior to the initiation of the programme, shrubs (mainly *Cistus ladanifer*) were cleared and invasive eucalyptus trees in the intervention area were uprooted.

A week of specialised training was required for heavy equipment operators. Thereafter, topographic regrading and construction was undertaken using bulldozers (D6), with the construction of the GeoFluv channels and other landforms using multiple excavators. The earthworks achieved cut – fill balance (no exporting or importing materials were needed). Despite minor deviations to plan were observed after heavy rainfall at the end of November 2021, periodic inspections confirmed satisfactory runoff management across the intervention area, although drainage from the encapsulated old pyrite stockpile led to local rilling (Figure 8).

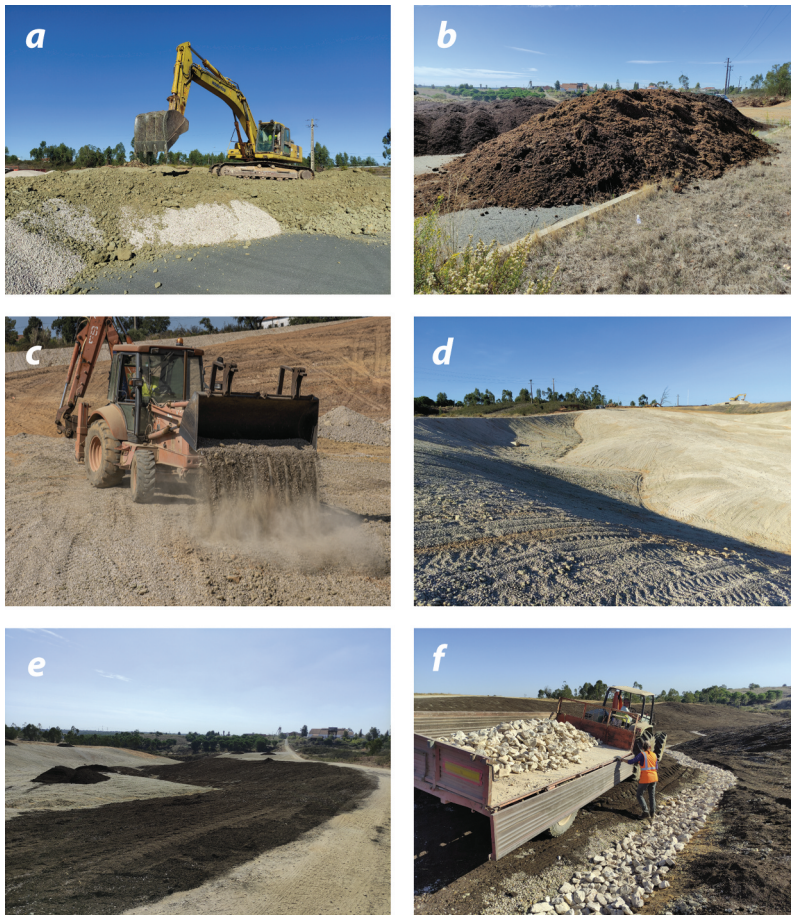
**Figure 10.** Execution of soil cover and AMD remediation actions: a) and b) materials used in the construction of the soil cover, limestone gravel and clays (a), and animal manure and topsoil (b); c) extension of the materials over the rehabilitation area with a backhoe; d) view of the intervention area after the extension of the soil horizon B; e) view of the first stages of the extension of the soil horizon A; f) lining of limestone blocks over the GeoFluv designed channels.

Remediation began in October and was completed in November of 2021. It commenced with the creation of the soil layers using heavy equipment for batch mixing (Figure 10), with soil spread mechanically by backhoe and where required, manual labour. As uniform thicknesses were difficult to achieve, additional limestone gravel and clay materials (Horizon B) were added where AMD was anticipated. In headwaters and elevated ground, Horizon A was intentionally thickened to accommodate rain, wind and gravity settling. After implementation of the soil cover, the limestone neutralisation channels were constructed as described above, using both heavy machinery and manual labour.

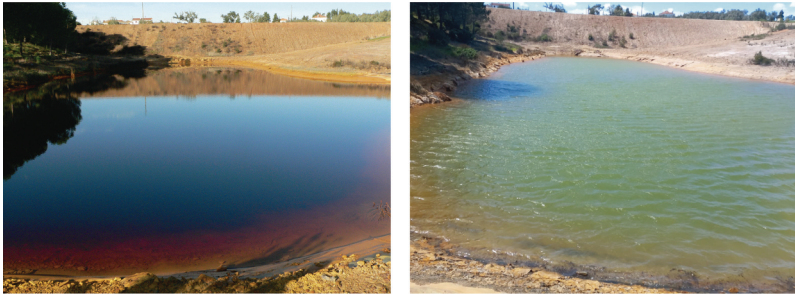
**Figure 13.** AMD drainage pond located down waters from the intervention area. Left, view of the AMD drainage pond in January 2020. Right, view of the AMD drainage pond in April 2022.

Concerning the remediation strategy on the water quality of the AMD pond, the comparison of data from 2017 to 2022 offers few differences in terms of pH (2.2 to 2.6), ORP (740 to 226 mV) and EC ( $4800$  to  $3018 \text{ } \mu\text{S cm}^{-1}$ ). The differences in some PTEs concentrations are more significant, especially in Fe ( $404$  to  $34 \text{ mg L}^{-1}$ ), Zn ( $65.7$  to  $15.8 \text{ mg L}^{-1}$ ) and Cd ( $122$  to  $0.8 \text{ } \mu\text{g L}^{-1}$ ). The Cd and Pb are lower than those established by the Portuguese Legislation for acceptable water quality in surface waters (Pb –  $0.05 \text{ mg L}^{-1}$ , Cd –  $0.01 \text{ mg L}^{-1}$ , Zn –  $0.5 \text{ mg L}^{-1}$ ) [41], which may indicate marginal improvement in water quality after remediation.
